Site Investigation Report

Trough Laithe Farm,

Barrowford Road, Barrowford

17 September 2014

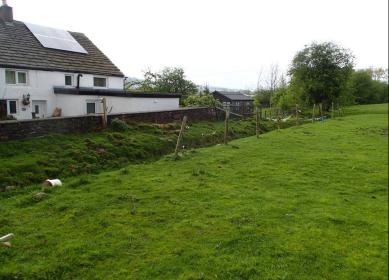
Photograph 12: Stone wall at the north eastern corner of the eastern field.

Photograph 13: Second image of wall shown in Photograph 12

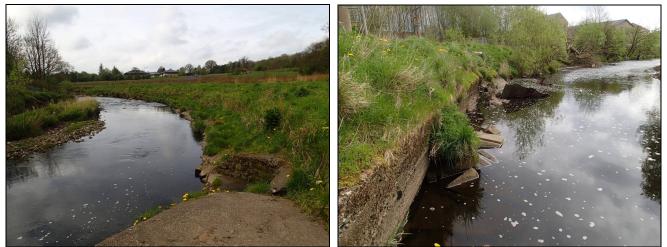
Photographs 14 & 15: Course of Pendle Water looking west and east. Erosion of the riverbank had broken concrete headwalls and sheet piles.

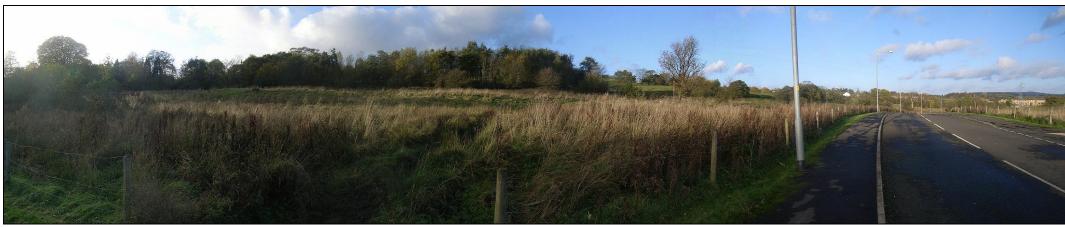
Photograph 17: Panorama showing extent of site from access road and land in the southern area of the site.

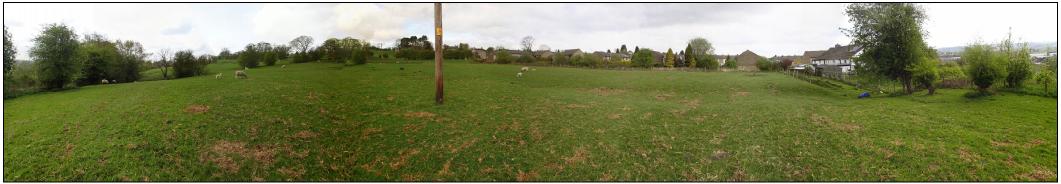
Photograph 18: Panorama showing extent of the eastern field from its southern boundary.

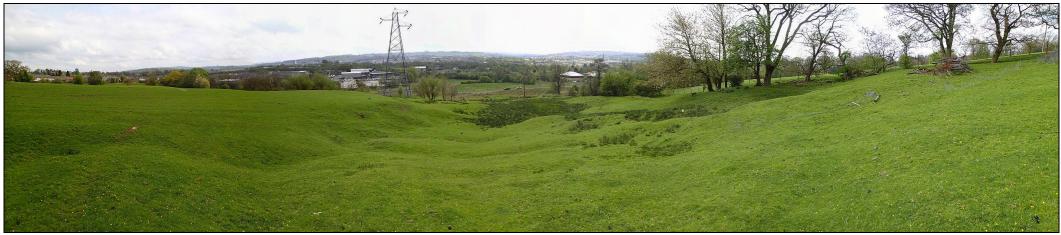
Photograph 20: Panorama showing the basin area within the central area of the site, taken from the north.

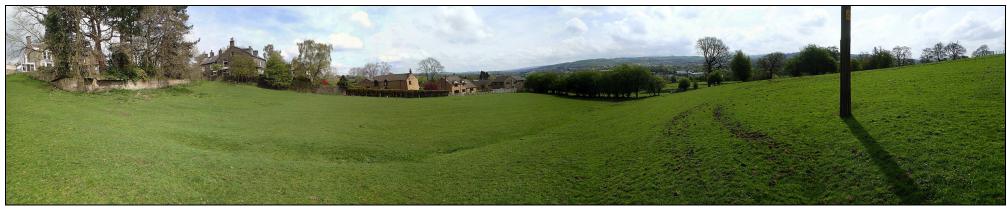
Photograph 21: Panorama showing the extents of the northern field from its western edge

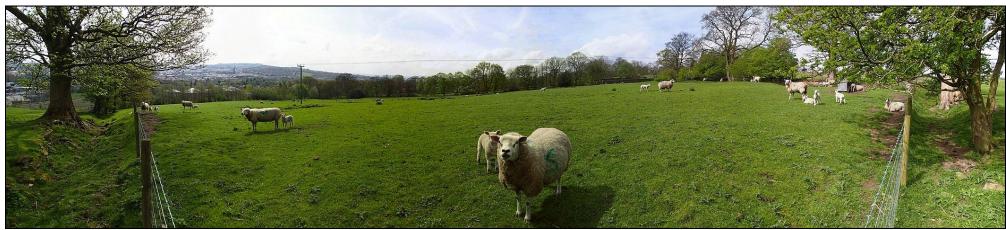
Photograph 22: Panorama of the western field from its northern edge

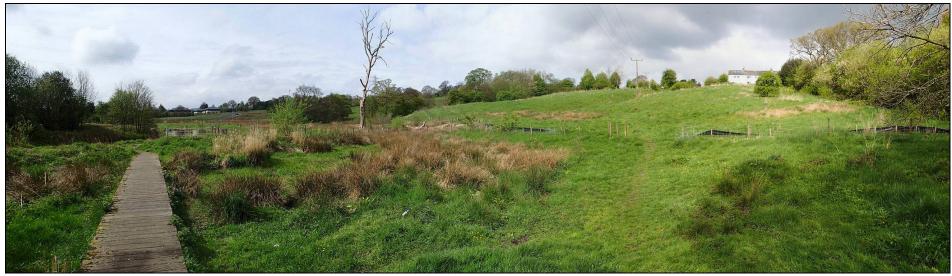
Photograph 24: View from the southeastern corner of the site looking west and north with the compensation pond either side of the timber walkway.
