**REPORT FROM: PLANNING, BUILDING CONTROL & LICENSING SERVICES
MANAGER**

TO: Colne & District Committee

DATE: 7th February 2019

Scar Top Mill, Trawden

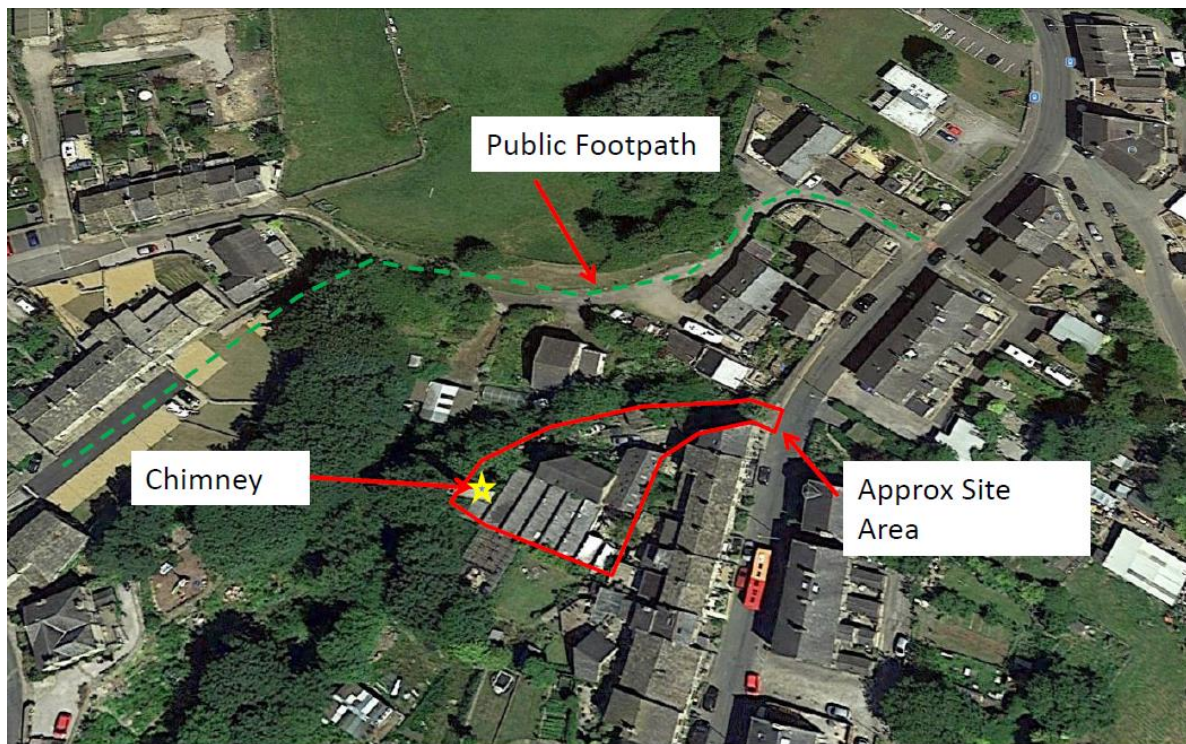
- 1 Scar Top Mill is a north light stone built building found off Church Street in Trawden. An annotated aerial photograph is included below of the site and the public footpath network around it. The site sits behind a row of terraced properties which in turn lie on land rising in a north to south general direction. The site sits below the terraced properties. We have not been able to get on site to measure the height difference but it is some 3-6m. Beardshaw Beck flows immediately to the northern boundary of the site and there is a retaining wall above the beck. The site itself is accessed off a single width poor access (Appendix (i)). It contains stone buildings on the northern side with north light structures to the southern side. Both the east and south boundaries of the site have high walls that act as retaining structures for the land beyond. There is a mill chimney on the western extremity of the site.

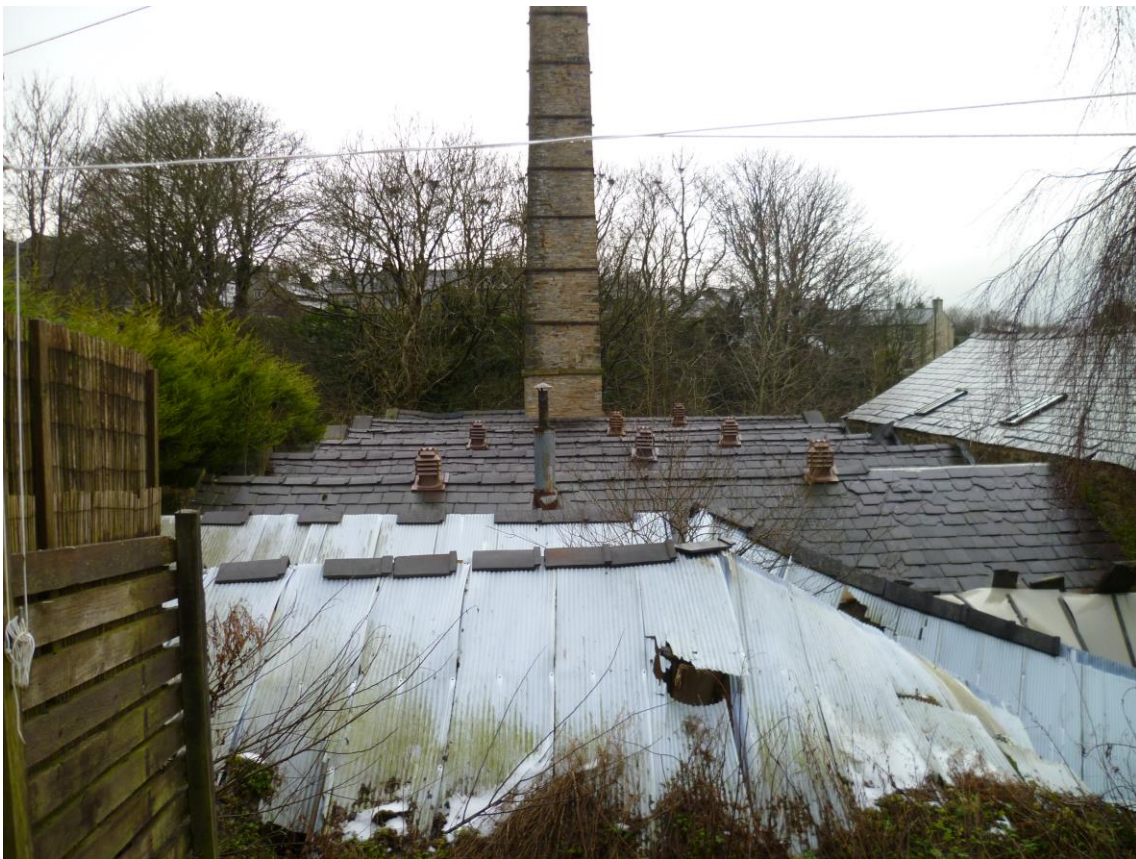
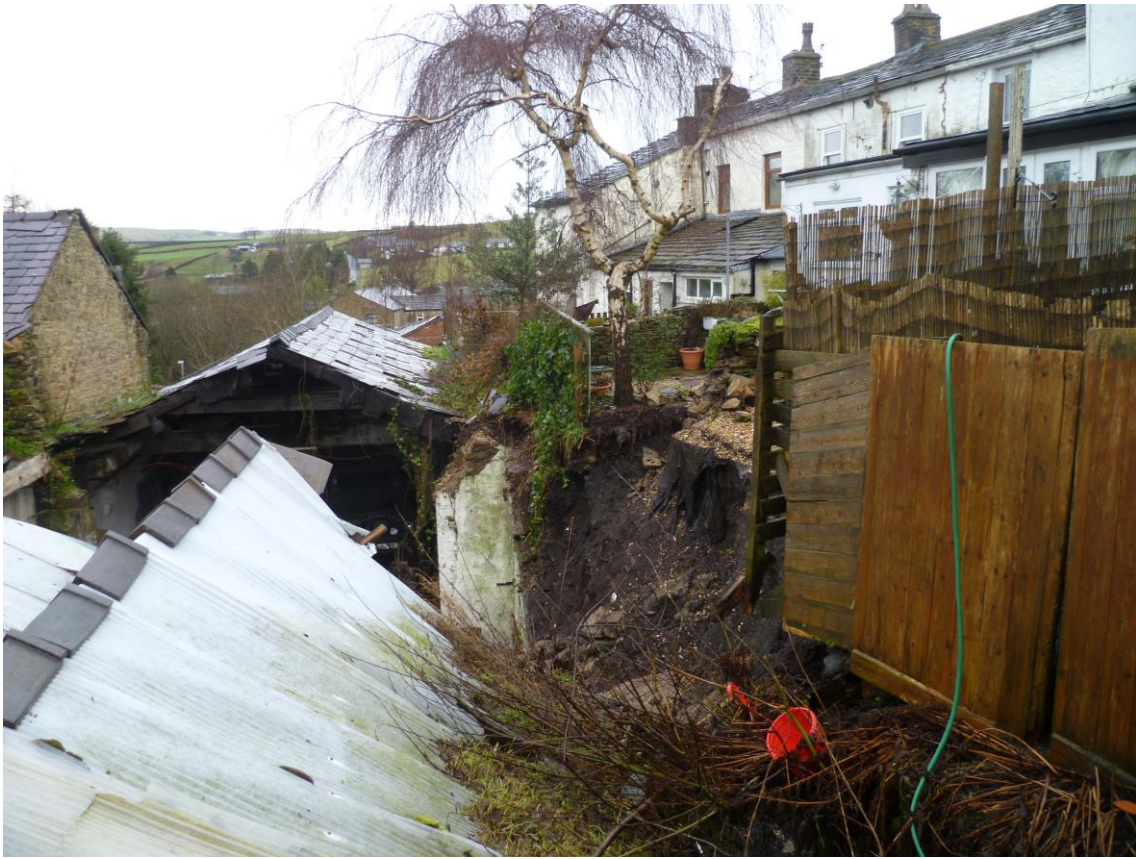
Appendix (ii)

- 4 The wall on the eastern side of the building suffered a partial collapse 12 months ago (see photographs at Appendix (ii)). That has been monitored by building control who keep in touch with the landowners. We secured structural engineers to advise us on the structural integrity of the buildings and we gave advice to the property owners about how to use their properties. Under the building regulations our duty is to abate the danger which we have based on current ground conditions. The house holders are dealing with the issue of a long term solution to this with their insurers. We understand that agreement has been reached to carry out remediation work but they have not been able to access the mill site to carry out the work. We have explored whether we are able to help with securing access but as this is a private matter we have no powers to do so.
