# TPO/NO5/2020- Land to the rear of 175-187 Cotton Tree Lane. Officer's Notes

# Tree Evaluation for Preservation Order

<b>TPO Reference:</b>	TPO/NO5/2020	<b>Tree/Group Number:</b>	T1
<b>Owner:</b>	Trawden Parish	<b>Location:</b>	Land to rear of 175 - 187 Cotton Tree Lane
<b>Species:</b>	Silver Birch

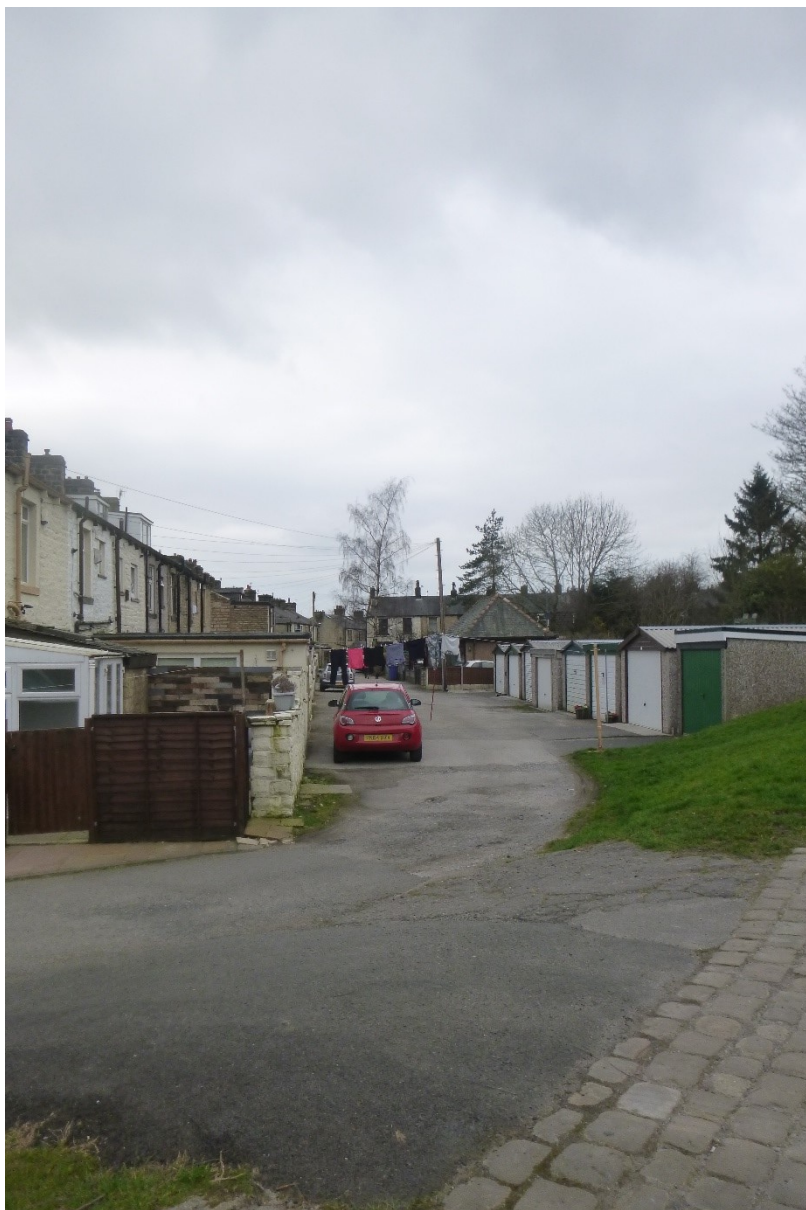
The tree is clearly visible from Hollington Street and the entrance to the tram tracks at the side of LBS. There are glimpses of the tree from the eastern end of the tram tracks. The tree can also be seen over the buildings at the corner of the allotments on Lambeth Street and Cotton Tree Lane.

*Figure 1 - Tree from adjacent to LBS building*

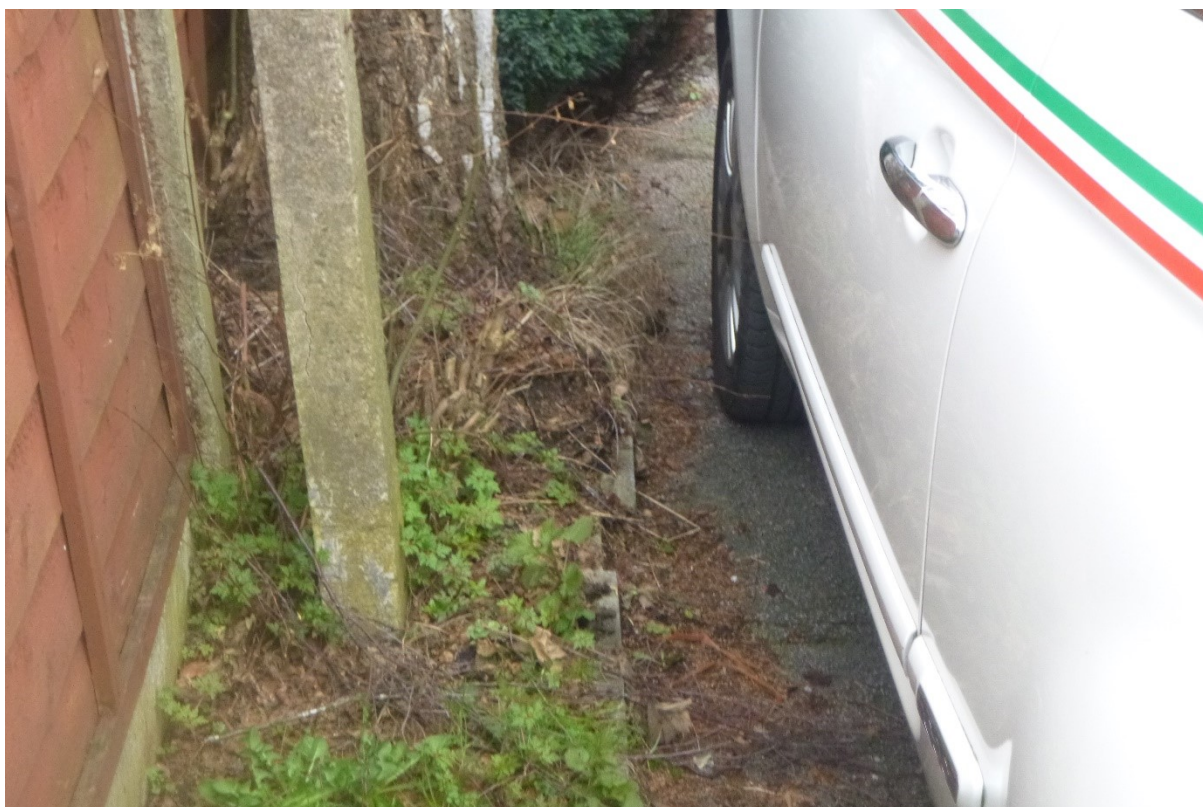
The tree is located between a fence and the kerb. The root flare at the collar is pushing against the fence causing a little damage. However, the garden does not form the curtilage of the adjacent property and the fence has been installed since the tree has been planted. The collar is also pushing against the kerb and has kicked it out a bit. However, at present this does present a hazard.

*Figure 2 - Damage to kerb*

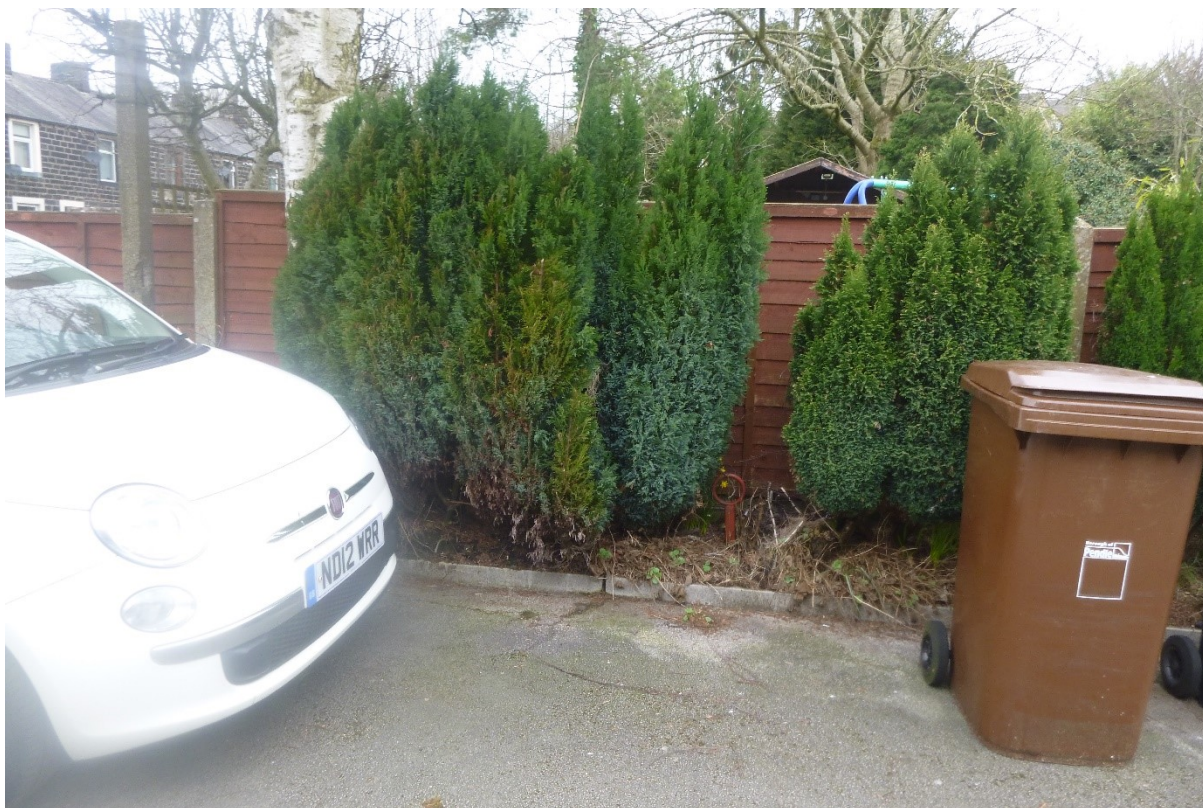
There is some cracking of tarmac within a meter of the tree. However, it is not directly in front of the tree and could as easily be attributed to the coniferous shrubs adjacent to the tree as to the Birch.

*Figure 3 - Tree and shrubs with tarmac cracking*

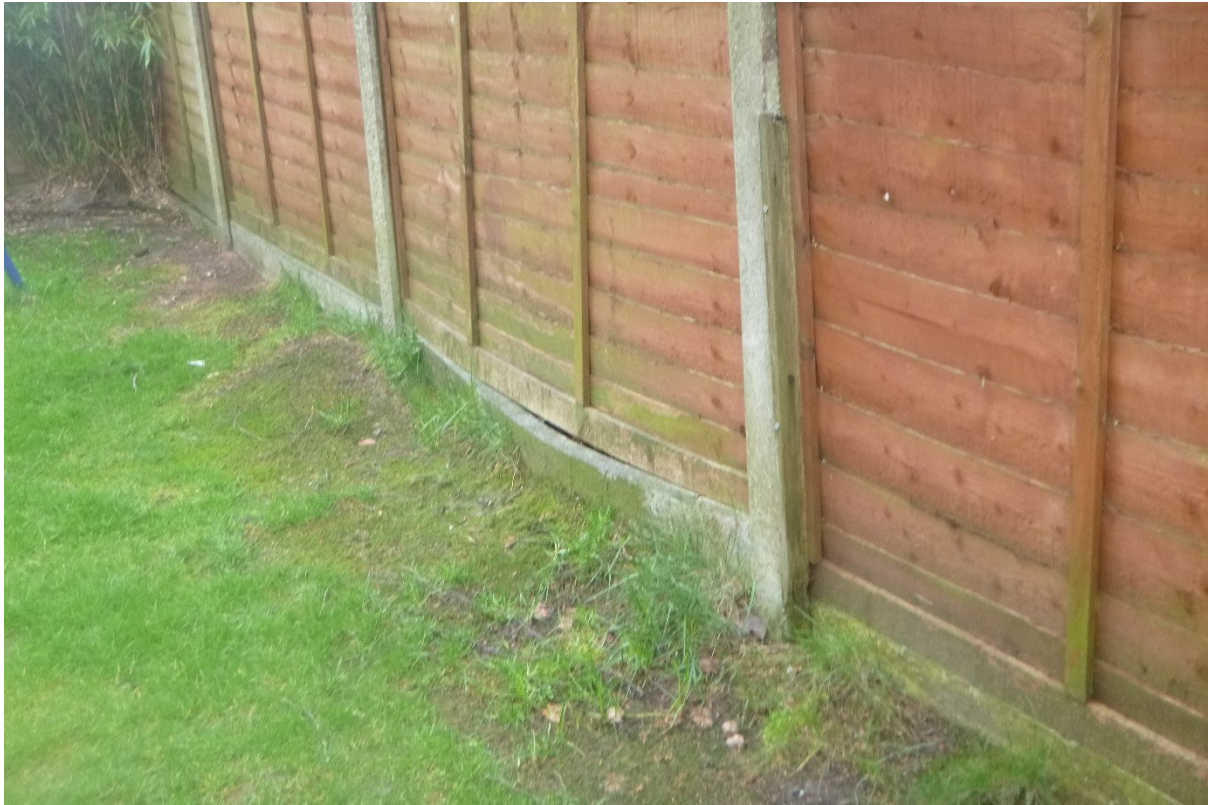
*Figure 4 - Damage to fencing*

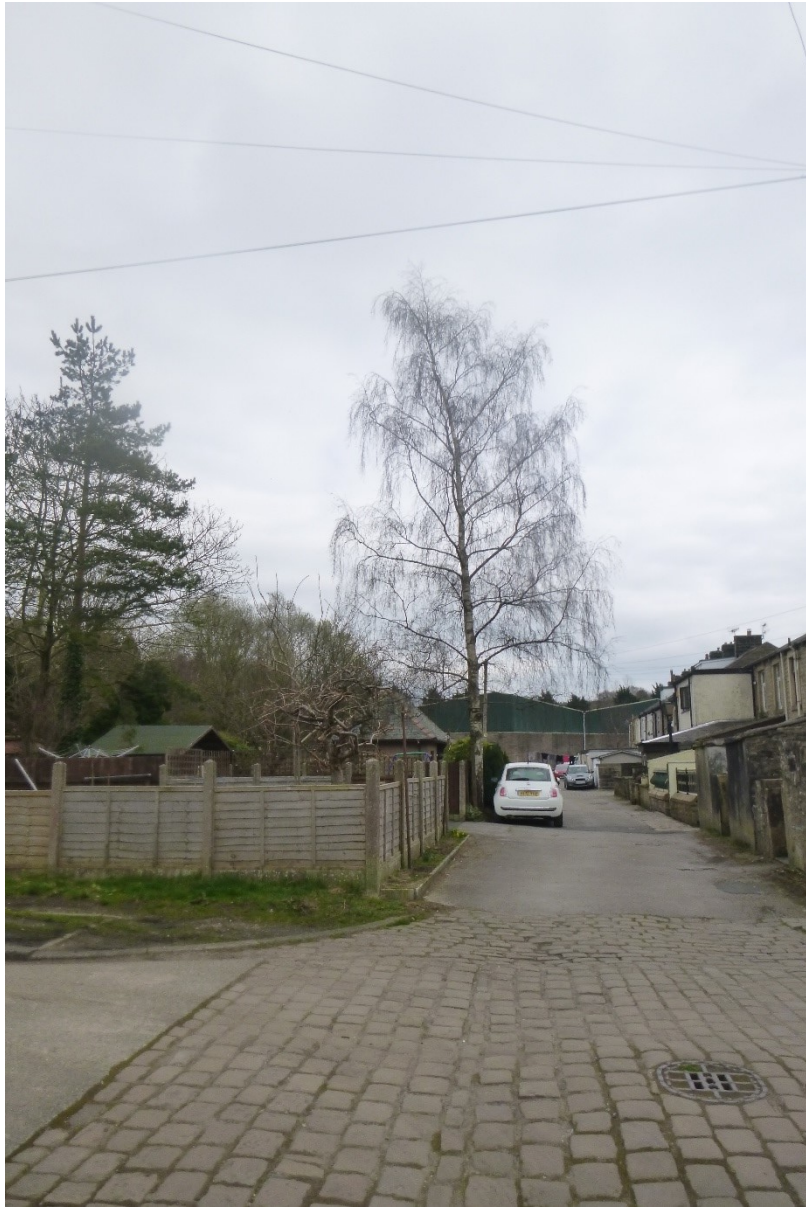
*Figure 5 - Tree from Hollington Street*

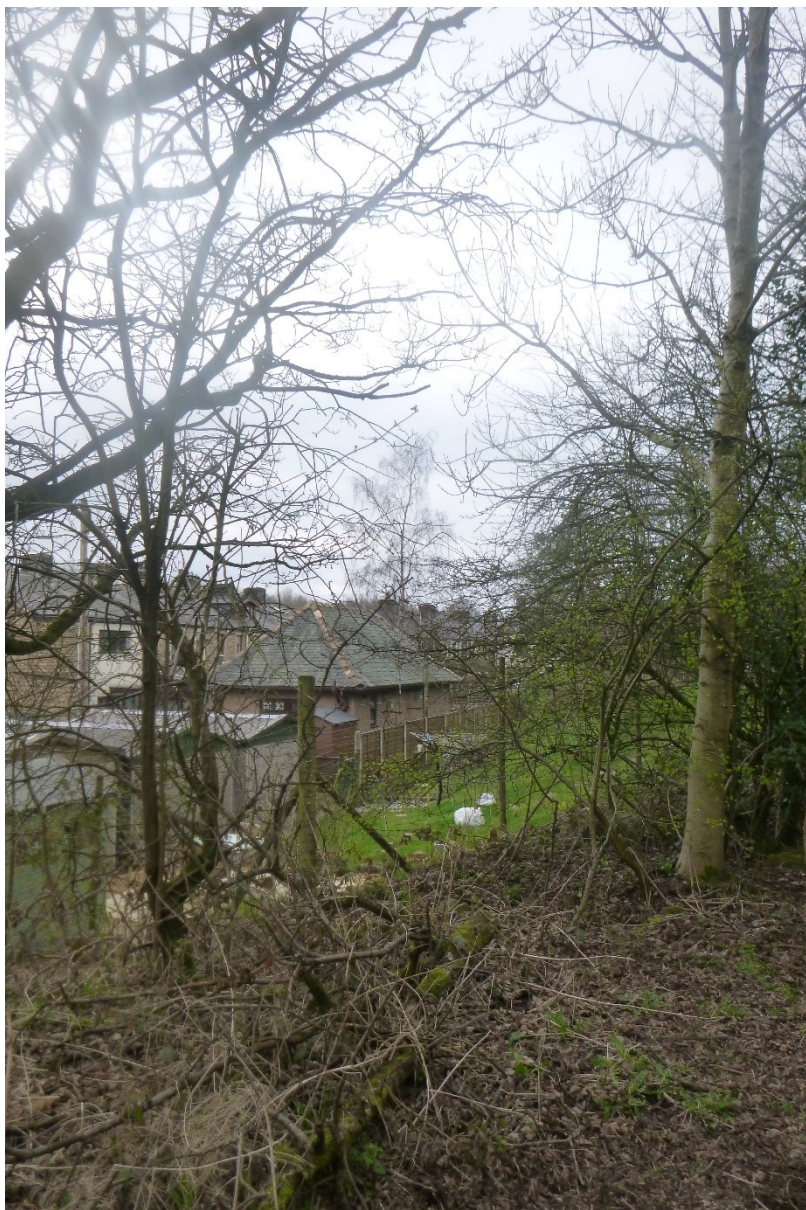
*Figure 6 - Tree (middle) from tram tracks*
