## **Pendle Borough Council**

### **Desk Study Report**

**Earby, Pendle**

**REPORT NO: 21PBC010/DS**

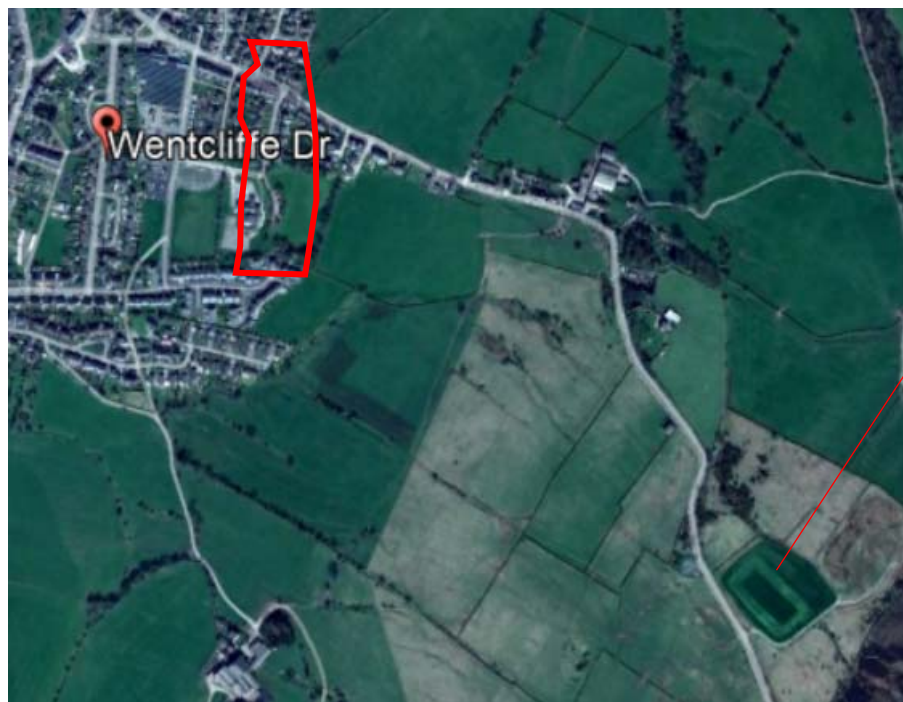
Google Earth 2011

Former Reservoir is no longer in use and looks to have been infilled

Between 2010-2011 the Earby Reservoir became disused and was infilled. Also, abstraction points became disused at an unknown date. This could have possibly caused ground and surface water levels to increase, and so with an increased amount of water contained within the permeable sandstone bedrock, water could have begun to migrate down the slope towards the site, increasing levels from 2011.

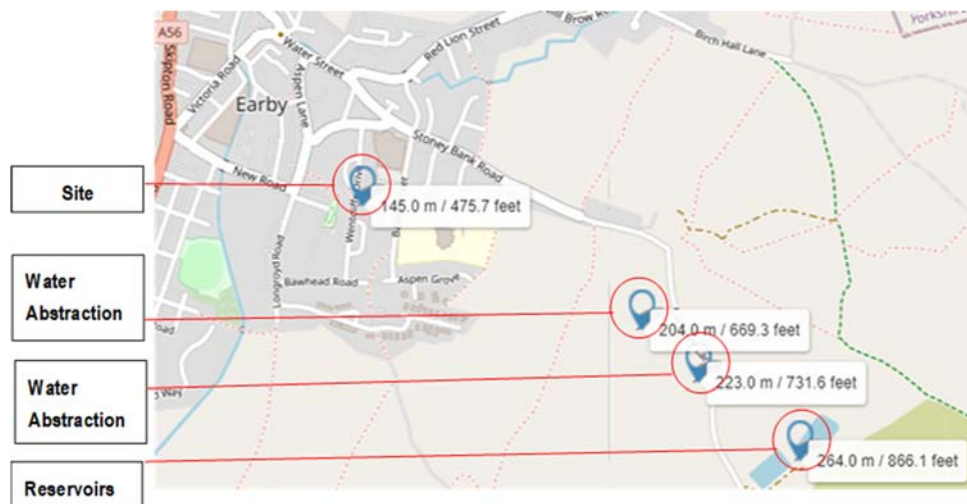
Elevation recordings from the site and the surrounding area shows the site to be located at the bottom of a steeply graded slope, running roughly 1000m East of the site.

The site has been located at an Elevation of 475.7ft, Water Abstraction 1 is recorded at approximately 669.3ft, Water Abstraction 2 is recorded at 731.6ft, and the reservoirs at the top of the slope are located at 866.1ft.

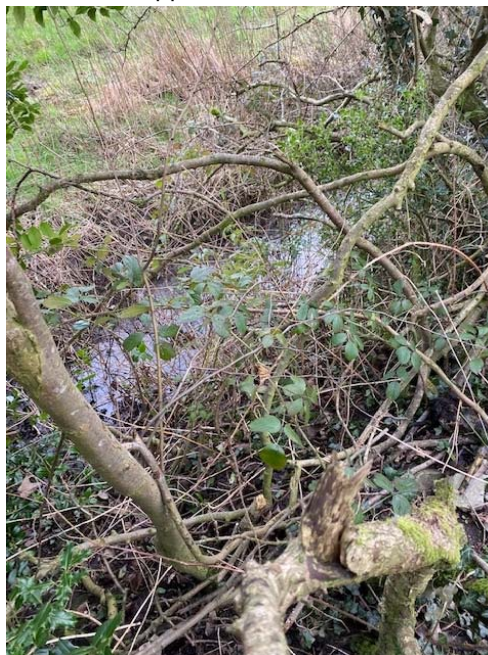
- 1) Water filled ditch along the footpath which runs north south along the field boundary to the east (accessed from Pleasant View). Water flow appeared to be to the South towards existing ditch / drain

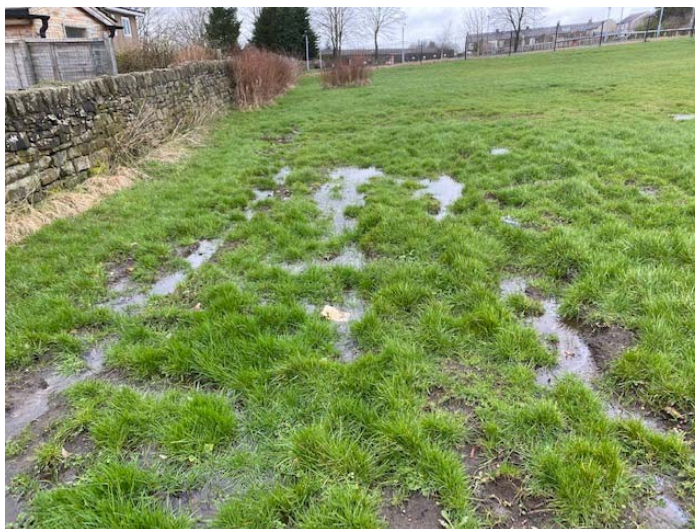
Looking north

- 2) Area of potential spring or broken drain welling out of the grassed area west of Aspen Grove – water flow was significant and direction of water flow to the west.

- Undertake hand pitting to establish the presence of the possible spring / broken drain features and the culvert features mentioned by PBC. Look at potential for further interception and routing to the known watercourse to the south. Care required so not to penetrate any clay cover and allow artesian water to emanate.
- Request geothermal boring risk assessment from third parties and Environment Agency request for comment on their Guidance Document and potential breach of water resource legislation.
- Request information from the BGS to establish if records were provided by the ground source heat pump drilling company (assess if greater than 15m to see if any breaches of legal requirements to consult the BGS)
- Request decommissioning details from Yorkshire Water and Environment Agency for the water abstraction wells upon the hillside.

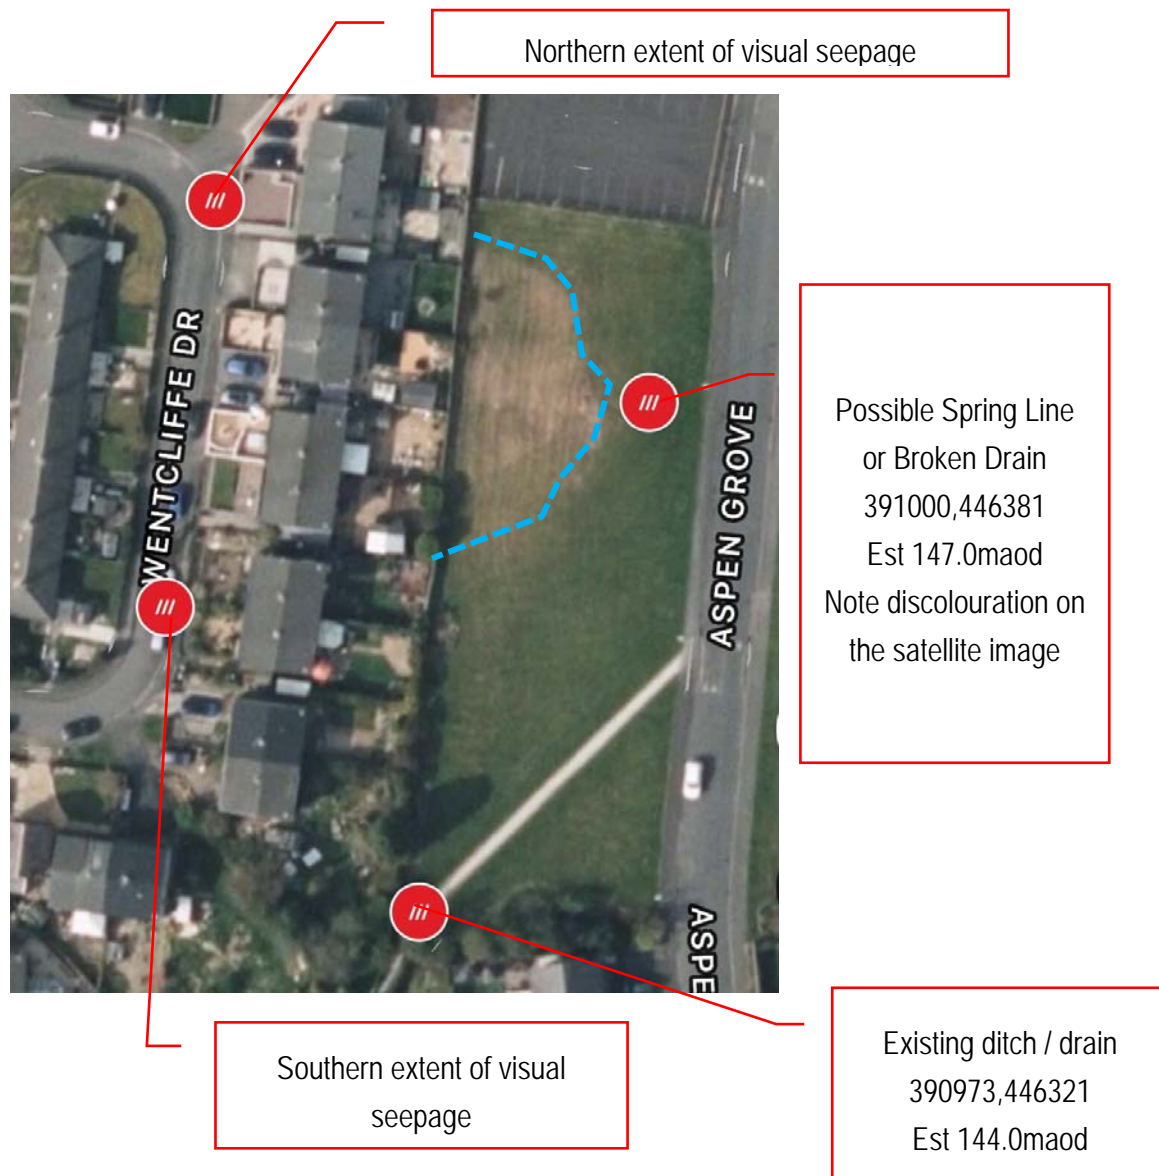
The houses directly west of the suspected spring (2) had water running along their frontage.

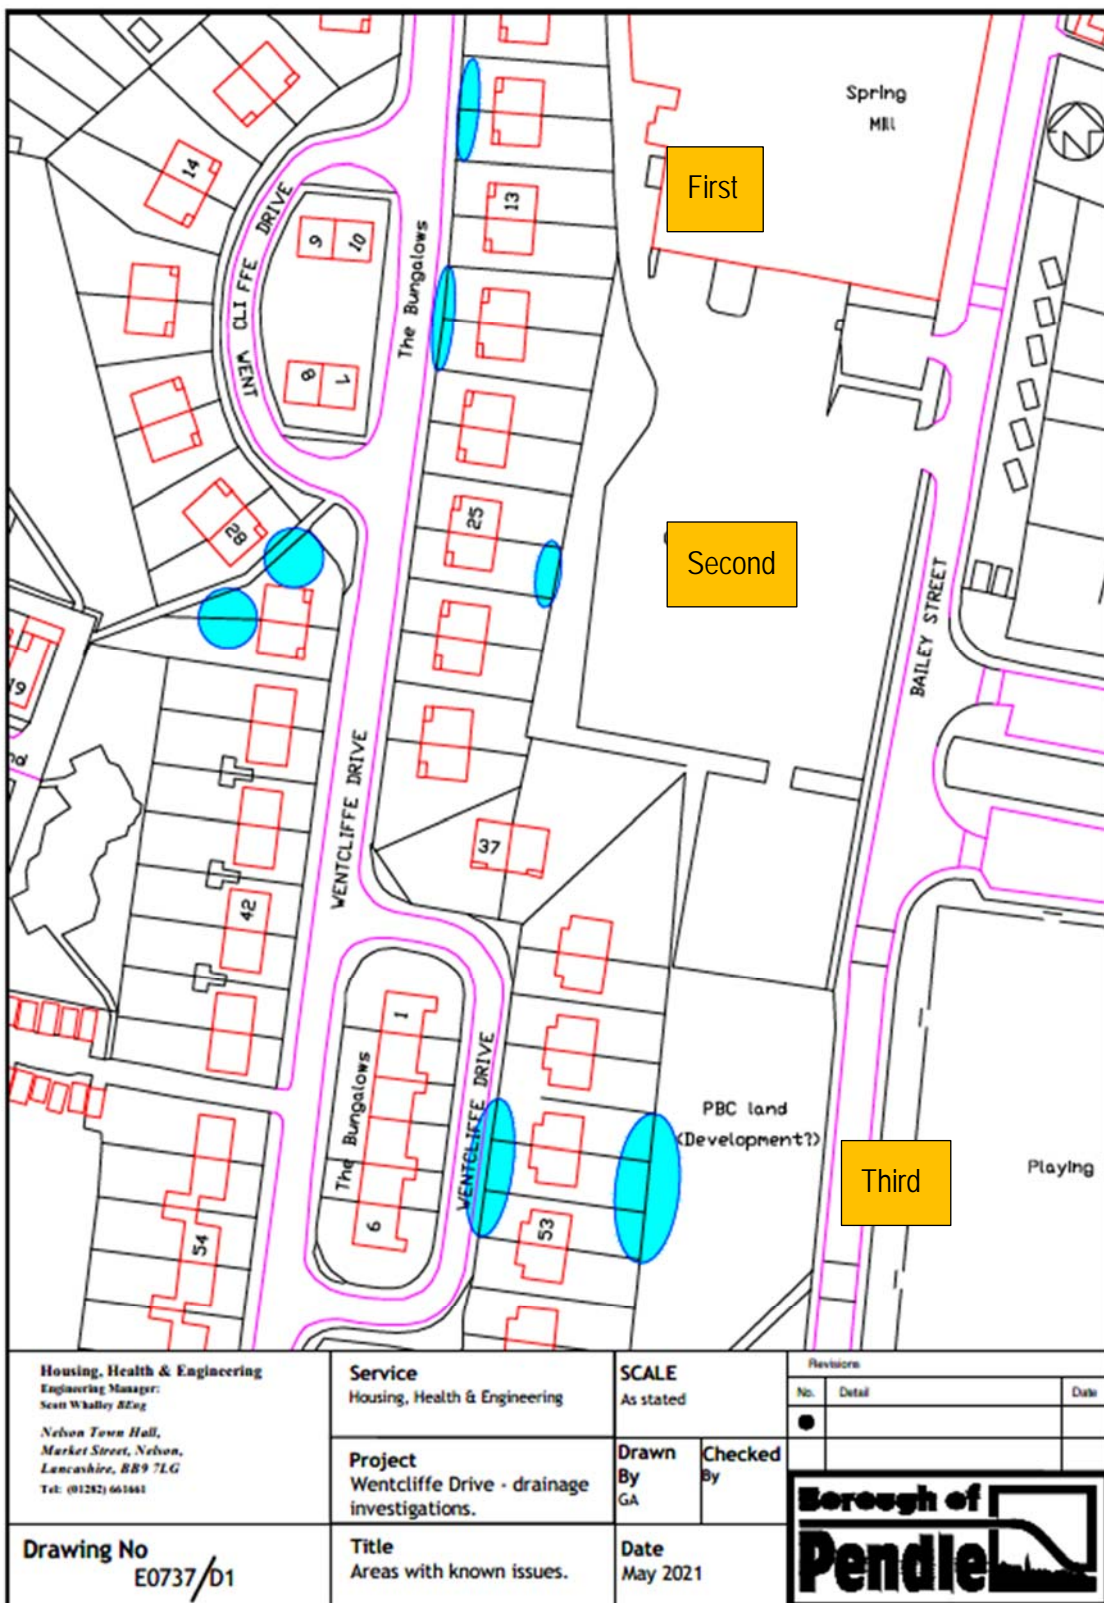
There are three areas of groundwater flooding as identified on the Pendle drawing below and confirmed during the walkover.

The first area is believed to be associated with the spring / drain feature – from the walkover the area appears to have grown larger to the north.

Second – probably the same body of water / spring line but emanating from the car park area.

Third – around the houses at 30 Wentcliffe Drive which is potentially influenced by GSHP installed to the Bungalows no 7 -10, but it is also noted to be poorly drained soil in these gardens and in a low area – may just be holding surface water. Poorly drained soils were also noted at the Bungalows.

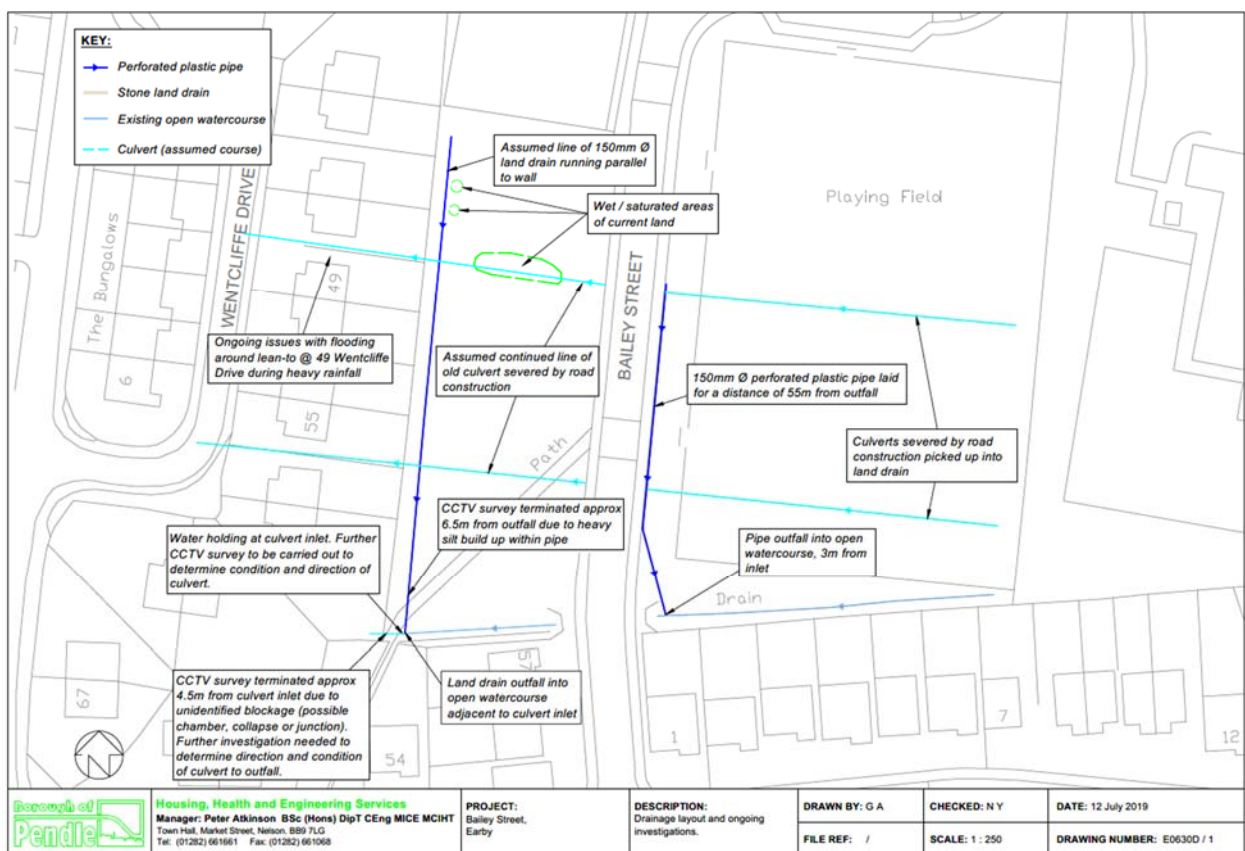
It is noted that a drainage investigation was undertaken by Pendle BC to establish if the old field drainage has been picked up along developed boundary and sports playing pitch and existing car park – shown below.
