TPO/NO1/2021 – Oakfield, Skipton Old Road, Colne

Tree Evaluation for Preservation Order

Date:	25/01/2021	Surveyor:	Lee Johnson					
Tree Details	Tree Details							
			Tree/Group					
TPO Reference	: TPO/NO1/2021		Number:	T1				
				SD 9048				
Owner:	Mr. P. Cunningham		Location:	4063				
Species:	Horse Chestnut

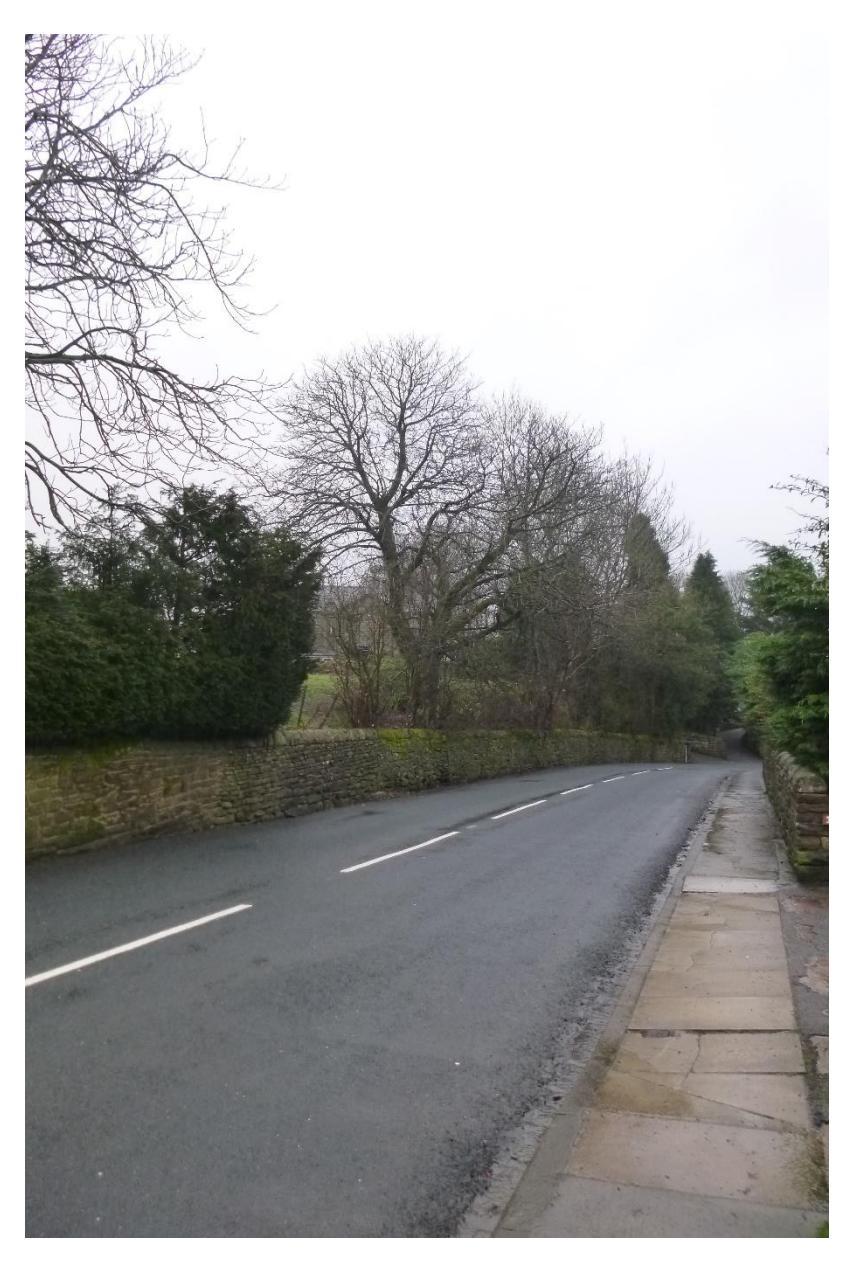
Figure 1 - Horse Chestnut from path on Skipton Old Road heading west from Bents

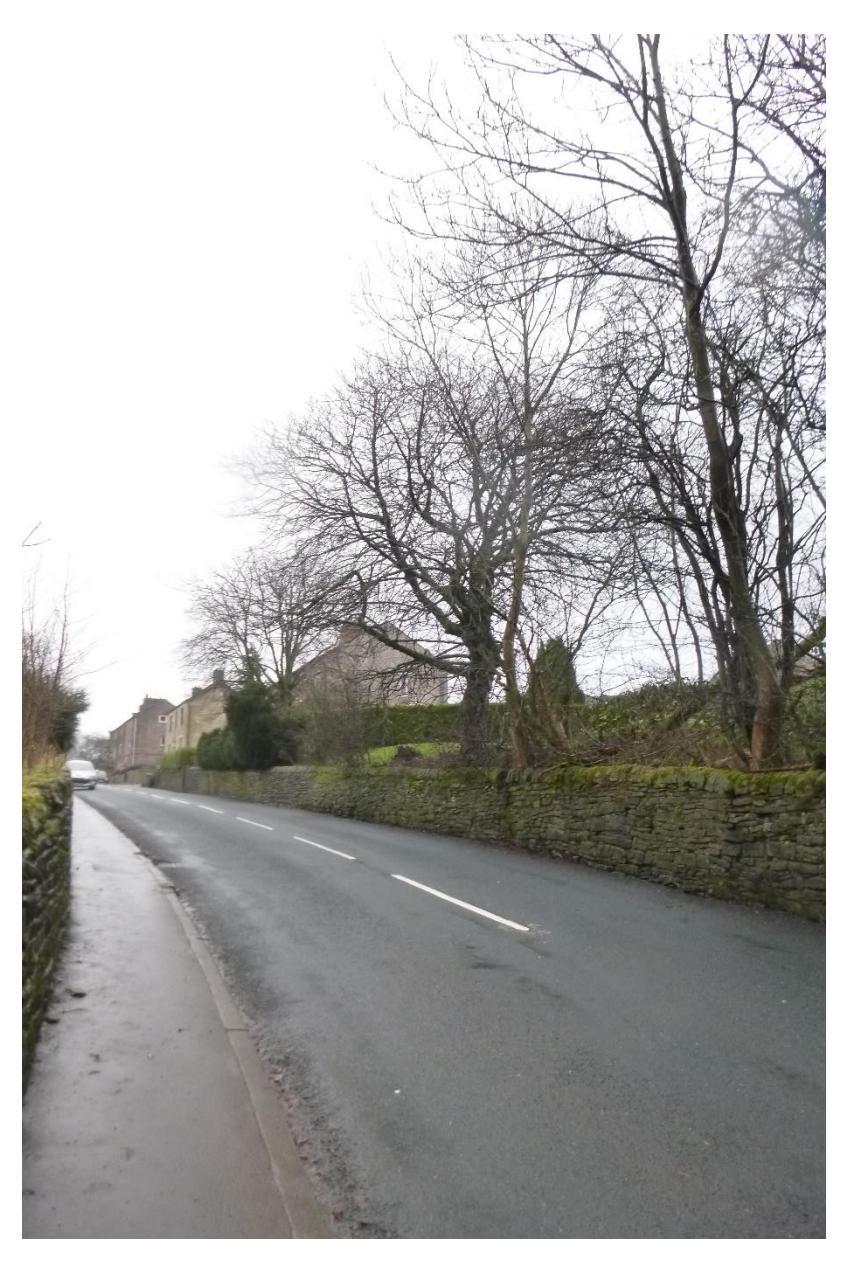
Figure 2 - Horse Chestnut from footpath on Skipton Old Road heading east from Lidgett

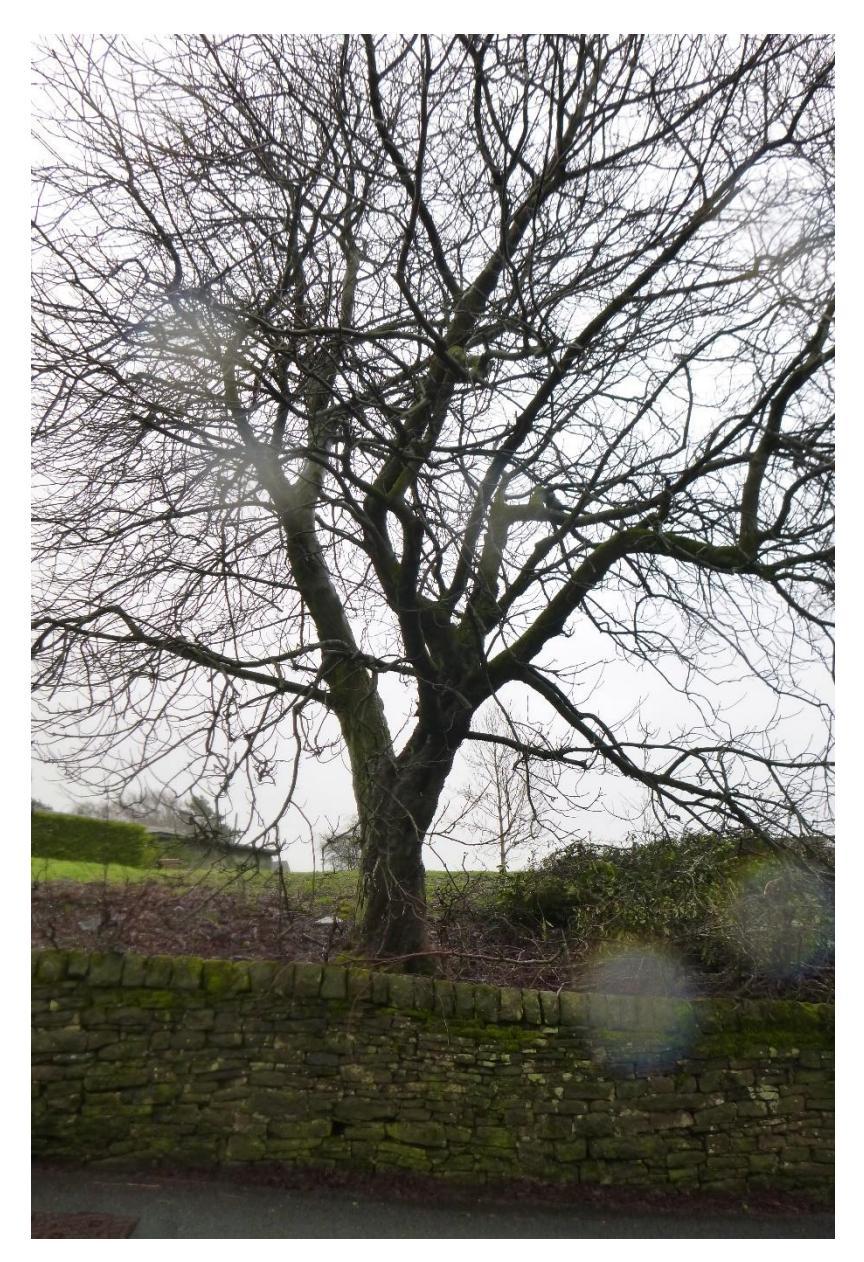
The tree roots are likely to be interacting with the drystone retaining wall that borders the property and Skipton Old Road in the possibility that they are within the gaps between the stones. The Principal Environment Officer and the Bridge Engineer from LCC have both examined the wall and agree that the tree is not causing damage at this point in time. As part of the planning application submitted on the site (20/0493/FUL) a report was supplied. The report was written by a well-respected arboricultural consultant. In their comments the consultant states 'In relative close proximity to top of retaining wall to Skipton Old Road. No major disturbance noted.'

Figure 3 - Horse Chestnut and wall

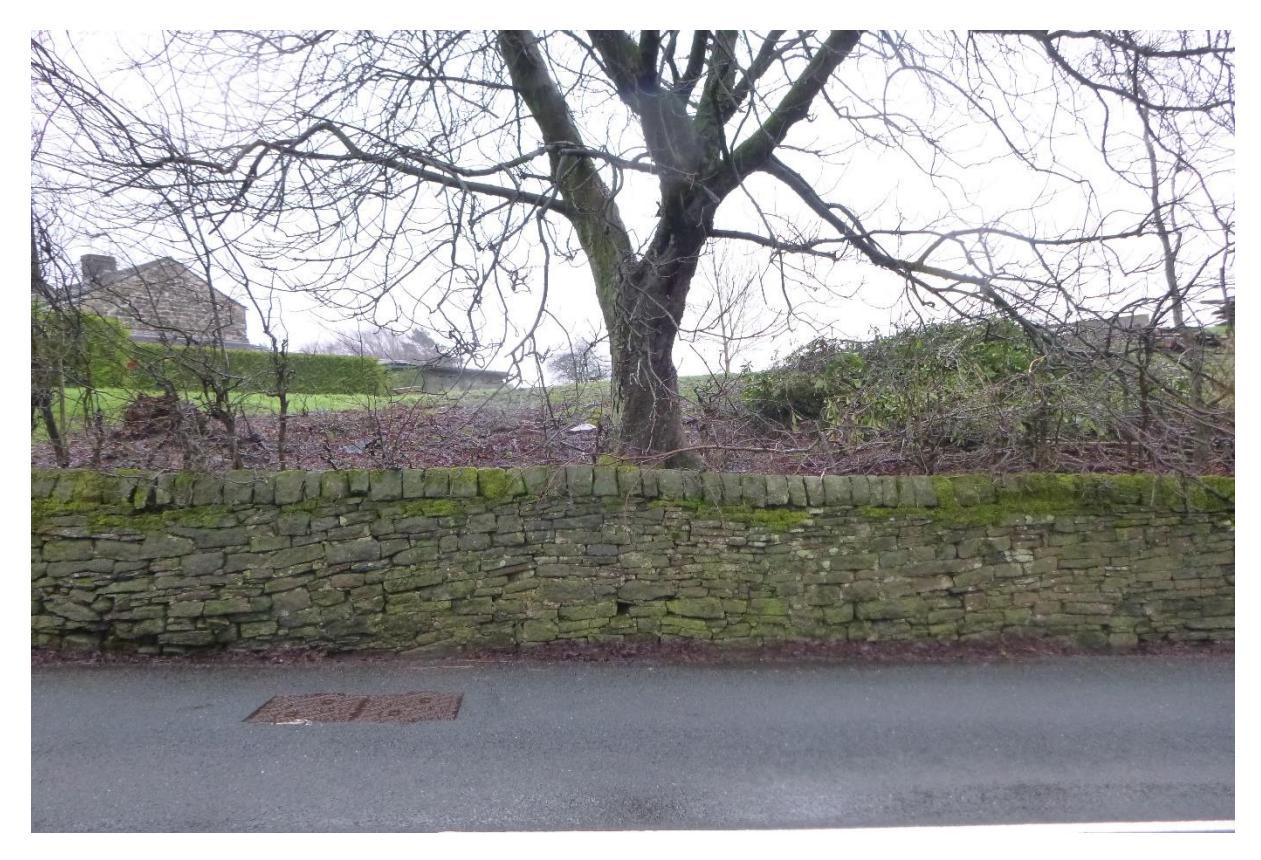
Figure 4 - Image of wall and tree
