REPORT FROM: HOUSING, HEALTH AND ENGINEERING SERVICES

TO: COLNE AND DISTRICT COMMITTEE

DATE: 2 DECEMBER 2021

ENVIRONMENTAL BLIGHT

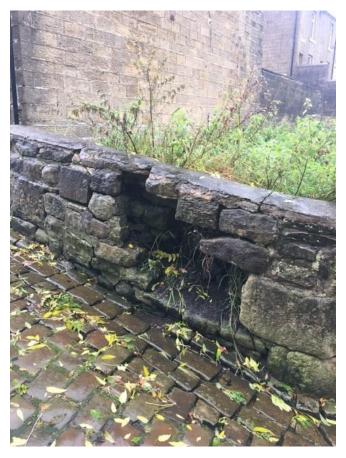
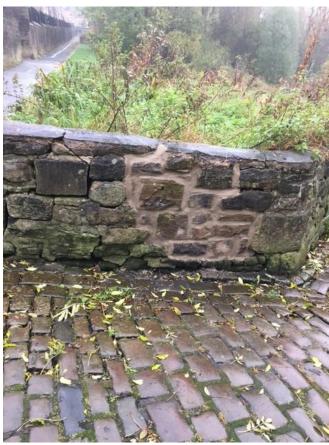
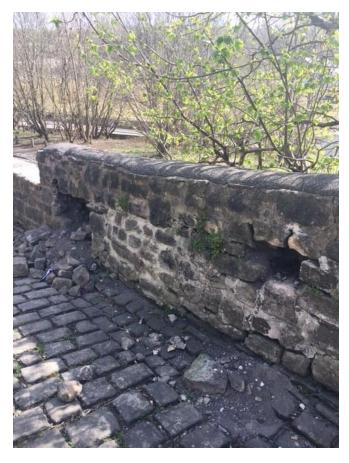
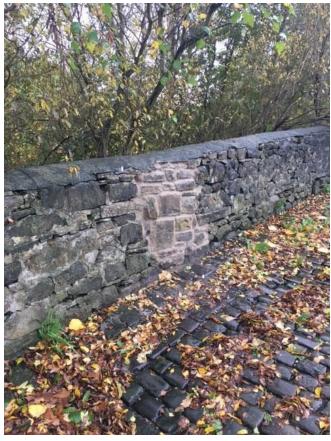
Duke Street Wall – Before and After Photographs

Site	Owner	Issue	Area Committee Resolution	Current Position
a) Cobbled area of Duke Street leading to Shaw Street (see attached location plan)	PBC-owned land; unadopted cobbled road	It was reported that rubbish was being dumped in an area that was being accessed due to a collapsed wall and fencing. Where the fencing was missing, people were fly-tipping	Following a site visit, it was agreed that we would price up for fixing the wall on Duke Street leading down to Shaw Street which needed repairs in a number of places to make it safe and to prevent it from further collapse. We would also get a price for repairing and refitting the missing fence panel which was found on site	The wall on Duke Street leading to Shaw Street has now been repaired/patched. We are waiting for a price to fix the fence panel
