**LANCASHIRE TEXTILE MILLS
STAGE 2 SURVEY**

**‘BUILDINGS AT RISK ASSESSMENT’ SURVEY
BOROUGH OF PENDLE
DRAFT REPORT**

JULY 2012

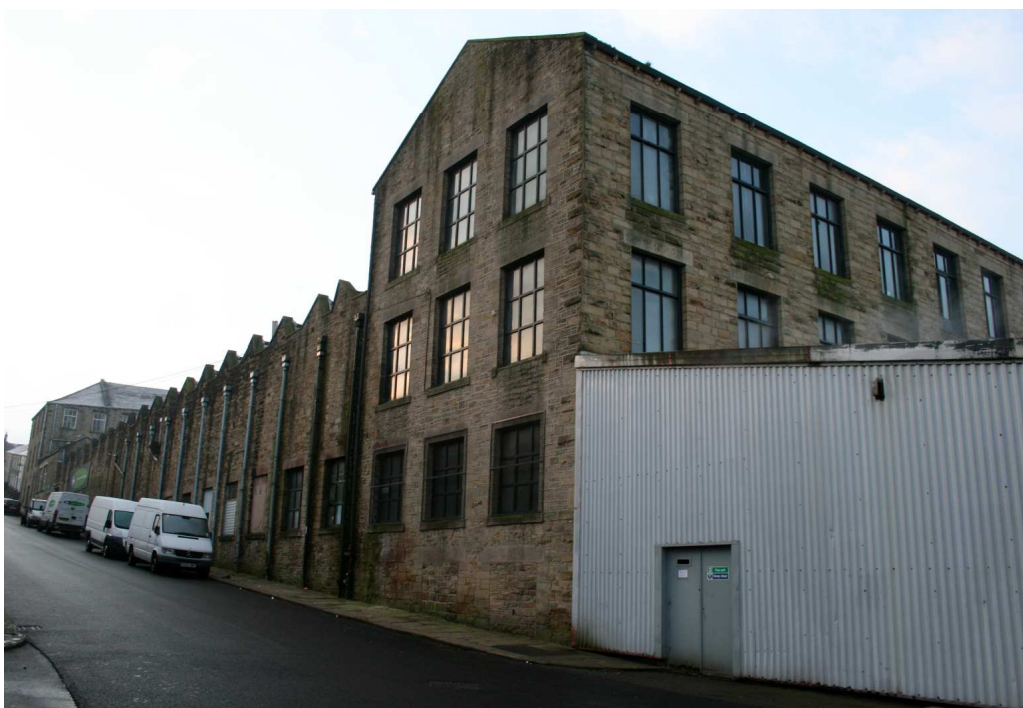
- 4.1.2 ***Derby Street Mill, Colne:*** Derby Street Mill was built by a partnership between J Crabtree and J Riddiough in 1891 as a steam-powered weaving mill. It had a warehouse and yarn preparation block of three storeys, basement and attics, a single-storey weaving shed of 430 looms and internal corner engine and boiler houses. In 1894 the mill was doubled in size to the north, the new weaving shed having its own warehouse and preparation block but utilising the existing power source which had been upgraded in 1891-2. The new weaving shed and warehouse have been dated by an inscription reading 'Derby Street Mill Extension 1894'. The mill's management was in the hands of the Derby Street Room and Power Company from 1896.

- 4.1.3 Derby Street Mill is in fair condition, and is occupied. The mill has a high *architecture and process* value, and a high *integrated site* value as all the principal components are largely complete.

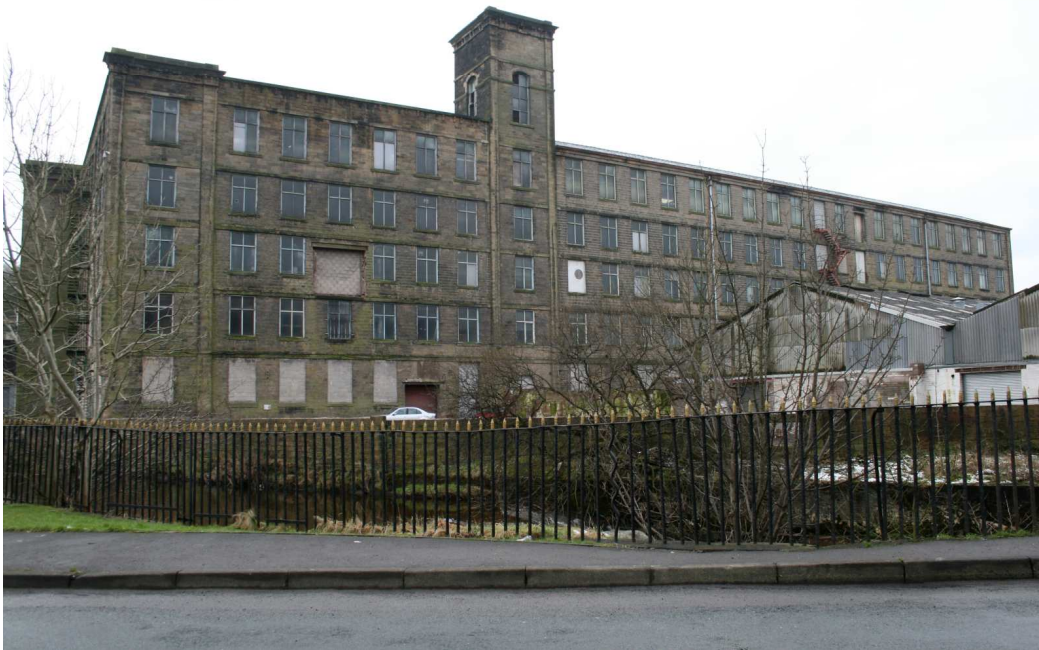
Spring Gardens Mill, Colne

- 4.1.4 **Spring Gardens Mill, Colne:** the mill was built in 1847 and comprised a semi-circular-shaped single-storey weaving shed at the north end of the site, and a multi-storey spinning mill. The original mill buildings to the west contain a five-storey main building, over a raised basement, 20 bays long by 6 bays deep, and of fireproof construction with segmental brick arches. Fire destroyed a large portion of the mill, although it was rebuilt as a four-storey block. The warehouse gained an additional storey, making it five-storey in 1889. The building is seven bays long and nine bays deep, of fireproof construction with quadruple brick arches. It is built over the earlier power source, a new boiler house being built at the rear. A new weaving shed with the capacity for 1200 looms south of and uphill from the mill addition was erected in 1892. The shed is single-storeyed but has a basement under its downhill end. 70000 spindles and 1656 looms were in operation at the mill by 1899, and the taping machines had separate buildings, alongside with a workshop, two weaving sheds and two engine houses and two boiler houses.

- 4.1.5 The mill is in fair condition, and is partly occupied. It has a high *architecture and process* value, and a high *integrated site* value as all the principal components are largely complete.
- 4.1.6 **Crescent Works, Colne:** erected in *c* 1924, Crescent Works provides a good example of a largely intact size and yarn preparation works. It is a rectangular, single-storey building built of stone to the front and of brick to the rear, and apart from a gabled boiler and engine house at one corner, the whole structure is roofed with glazed saw-tooth north-light trusses. Pedestrian and goods access was from the front, with separate and well segregated doorways for visitors and the workforce.

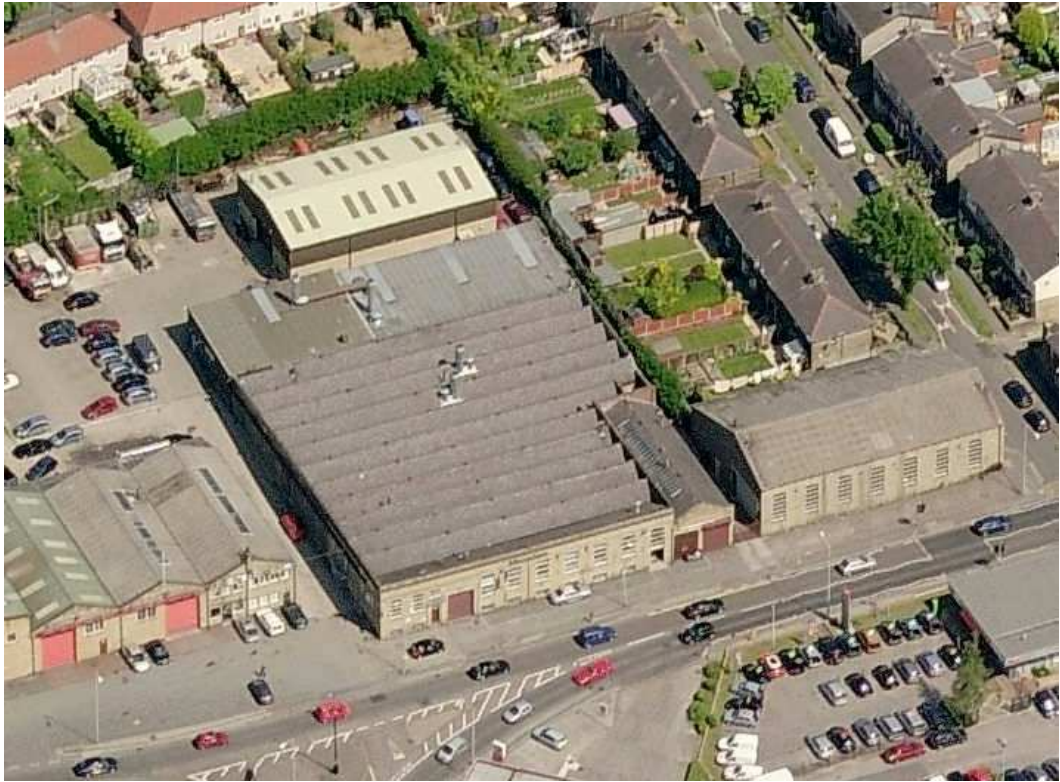
Aerial view of Crescent Works

- 4.1.7 The mill is occupied and is in good condition. It has an *architecture and process* value, and a high *integrated site* value as all the principal components are largely complete. It is a rare example of a twentieth-century textile size and yarn preparation works, and has a group value with the Stanley Street Works (LTM 0589) and Spring Works (LTM 0588).

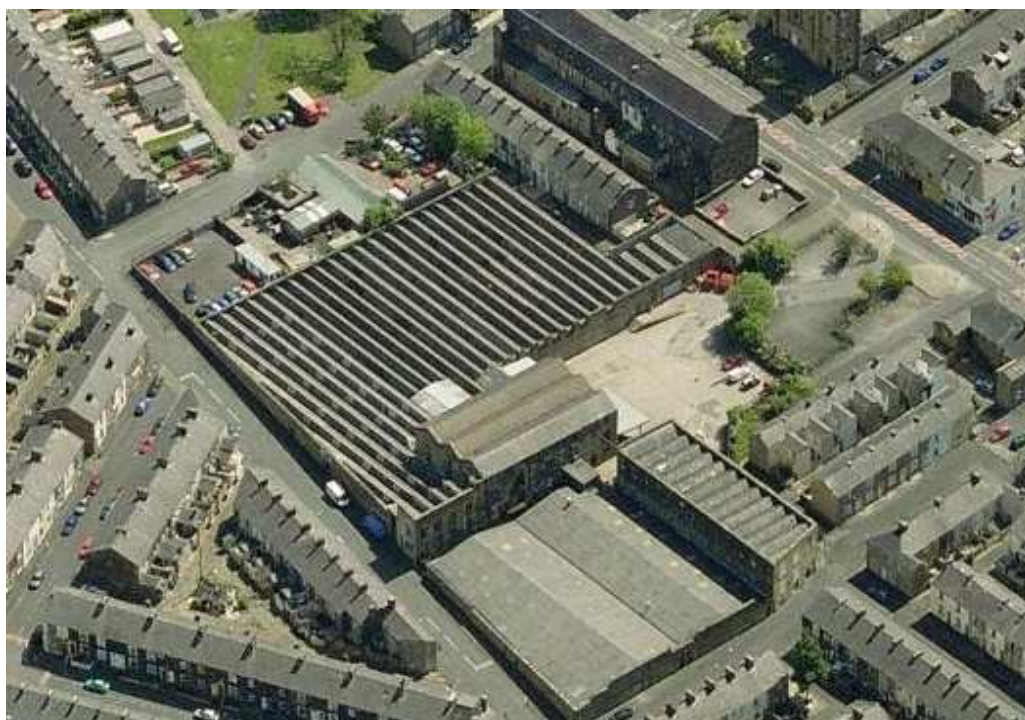
Aerial view of Throstle Nest Mill

- 4.1.8 ***Throstle Nest Mill, Nelson:*** Throstle Nest Mill originated in 1850-51 as a four-storey spinning mill, with a small weaving shed added subsequently. Constructed of watershot masonry with a stone gutter, the spinning mill occupies the centre of the site. The engine and boiler houses, and chimney, were attached to the southern end and have been demolished. However, an infilled wall box on the gable probably indicates the position of a vertical driving shaft. On the opposite side of the mill, a narrow, two-storey extension with northern light roof projects towards Bankhouse Road. A re-roofed weaving shed extends west of the mill to Throstle Street, and may incorporate the site of the original weaving shed. A two-storey warehouse and preparation building with yarn cellar and northern light roof form the southern corner. On the east of the former spinning factory as a larger weaving shed running along Bankhouse Road to Hey Street. A small extension from the main, rectangular shed is located at the south-west corner. The mill buildings have been much altered, and the steam plant has been lost, but the existence of the early building at the core of the site lends it some interest.

- 4.1.9 The mill is in poor condition, and is only partly occupied. The fabric of the complex clearly incorporates evidence for several remodelling episodes, perhaps associated with *technological innovation*. The site has a high *architecture and process* value, and is also associated with adjacent workers' housing, imparting a *wider industrial context* value.

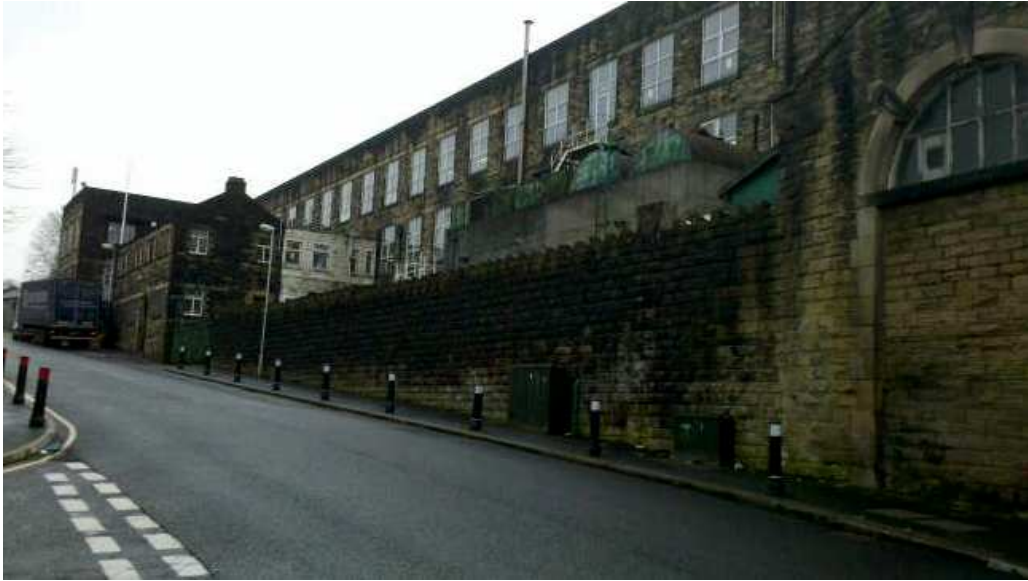
- 4.1.10 **Manor Mill, Nelson:** a steam-powered cotton-weaving mill planned in late 1919, Manor Mill is one of a cluster of six textile mills built between 1890 and 1929-30 in the valley of the Hendon Brook. An almost intact weaving shed, characteristic of many early twentieth century mills of Nelson, and the work of its architect, Richard Jaques. Yarn preparation, warehousing and motive power buildings are on the north of the site on Hallam Road. The main warehouse is 22 bays long and two storey high, with a yarn cellar extending under the western portion. A three bay extension, added in 1924, is built out from the north east end. A well-built, two-storey office is placed centrally, dividing the frontage into separate yards. The large engine house is attached to the western end of the warehouse, and has a keystone arched window facing the road. Adjoining is the boiler house which extends to the roadside. The rear portion, which probably held economisers, is topped with a cast-iron water tank. Behind is the reduced, circular brick chimney. The 18 bay weaving shed, built on a large plinth to compensate for the sloping land, runs to the south and has been partly re-roofed to accommodate jacquards. Stone corbels for the second motion survive along the internal, north wall. The mill survives largely intact, although the chimney has been reduced in height.

4.1.11 The mill is in fair condition, and is currently occupied. It has a high *architecture and process* value, and a high *integrated site* value as all the principal components are largely complete. It has a high group value with the Dale Mill (LTM 0595), Hendon Mill (LTM 0599) and Malvern Mill (LTM 0603), and associated workers' housing to the west, providing a *wider industrial context* value.

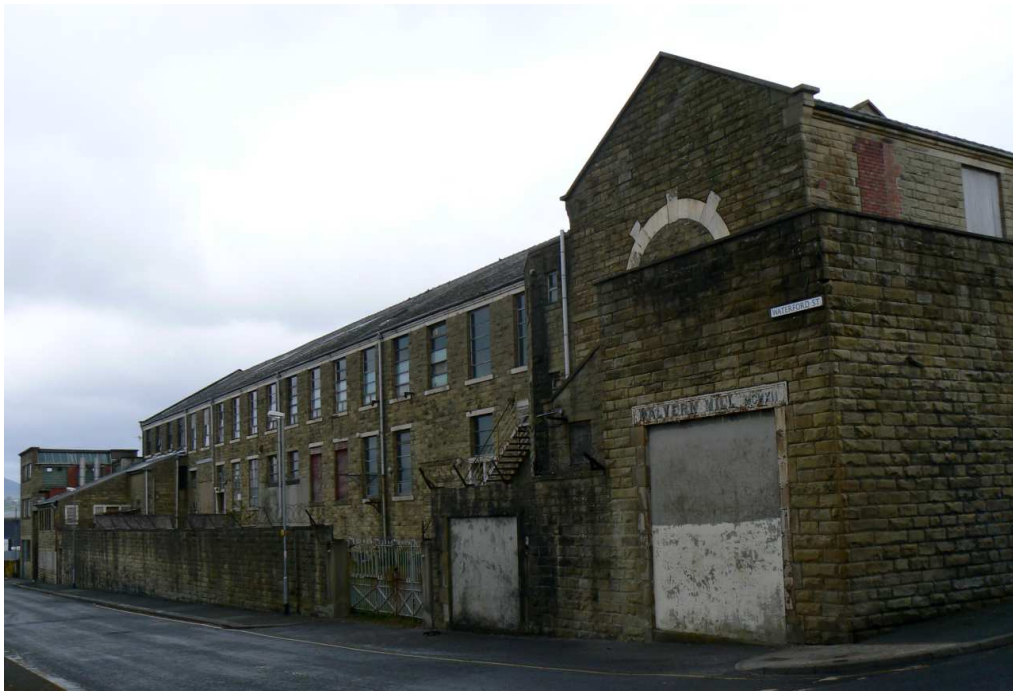
4.1.12 **Malvern Mill, Nelson:** Malvern Mill was built in 1912 to a design by Richard Jaques, the leading mill architect in the Nelson and Colne area. It is one of a cluster of six mills that were established on previously undeveloped land on the then eastern edge of Nelson. The mill survives largely intact, although the chimney has been demolished.

4.1.13 The mill is currently vacant, and is in fair condition. It has a high *integrated site* value as it is largely complete. It also provides a good example of an early twentieth-century weaving mill, and potentially has a value for *technological innovation*, as it represents an intact example of a purposes-built Edwardian weaving mill.

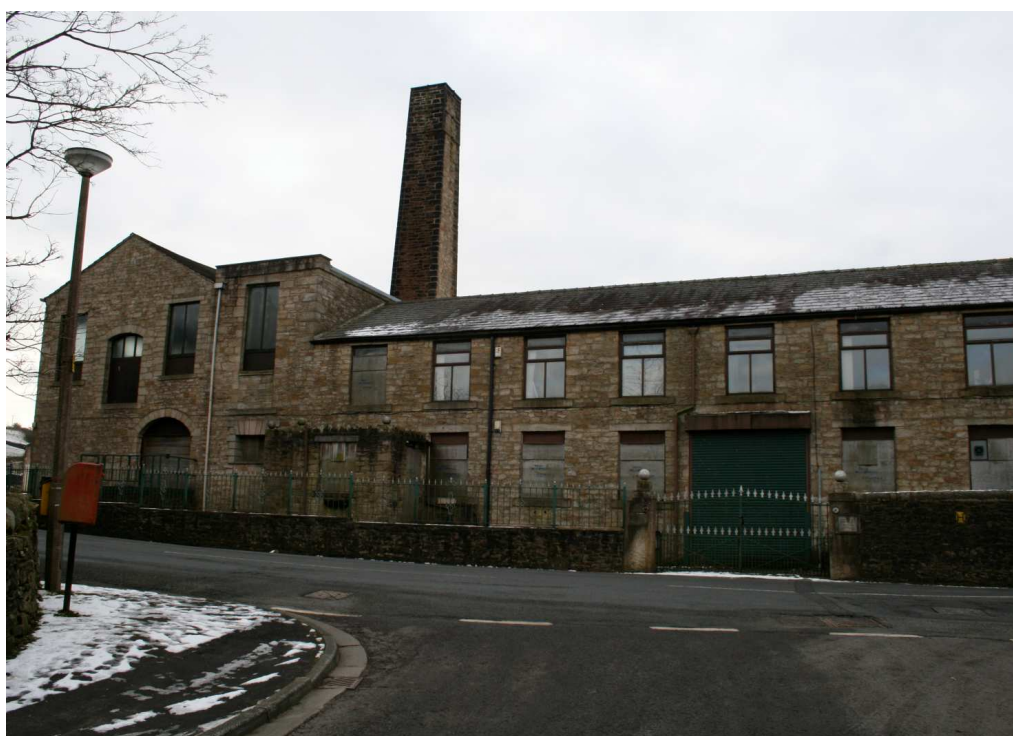
Spen Brook Mill

4.1.14 **Spen Brook Mill:** built in 1857 on behalf of the Newchurch Mill Building Company in a remote rural location, giving rise to the mill hamlet of Spen Brook. The mill originally consisted of a rubble-built multi-storey office, warehouse with a capacity of 300 looms and yarn preparation block, an engine house, boiler house and chimney, single-storey weaving shed, gasometer and reservoir.

4.1.15 The mill is in fair condition, but currently unoccupied. It has a high *architecture and process* value, and a high *integrated site* value as all the principal components are largely complete.
