Site Investigation Report

Trough Laithe Farm,

Barrowford Road, Barrowford

17 September 2014

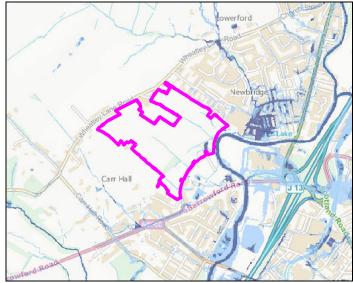
Figure 1: Surface water map of the area surrounding the proposed development site.

- 9.5 <u>Flood Risk</u>
- 9.5.1 According to the GroundSure EnviroInsight report, the site is not impacted by flooding from rivers, sea or reservoir. The Environment Agency have recently added surface water flooding to their online GIS databases but this has not been included within the GroundSure report. The mapping indicates that the site will be affected along the existing drainage channels and areas of former ponds by surface water flooding (refer to Figure 1 below).
