REPORT FROM: HOUSING, HEALTH AND ENGINEERING SERVICES

TO: COLNE AND DISTRICT COMMITTEE

DATE: 2 DECEMBER 2021

ENVIRONMENTAL BLIGHT

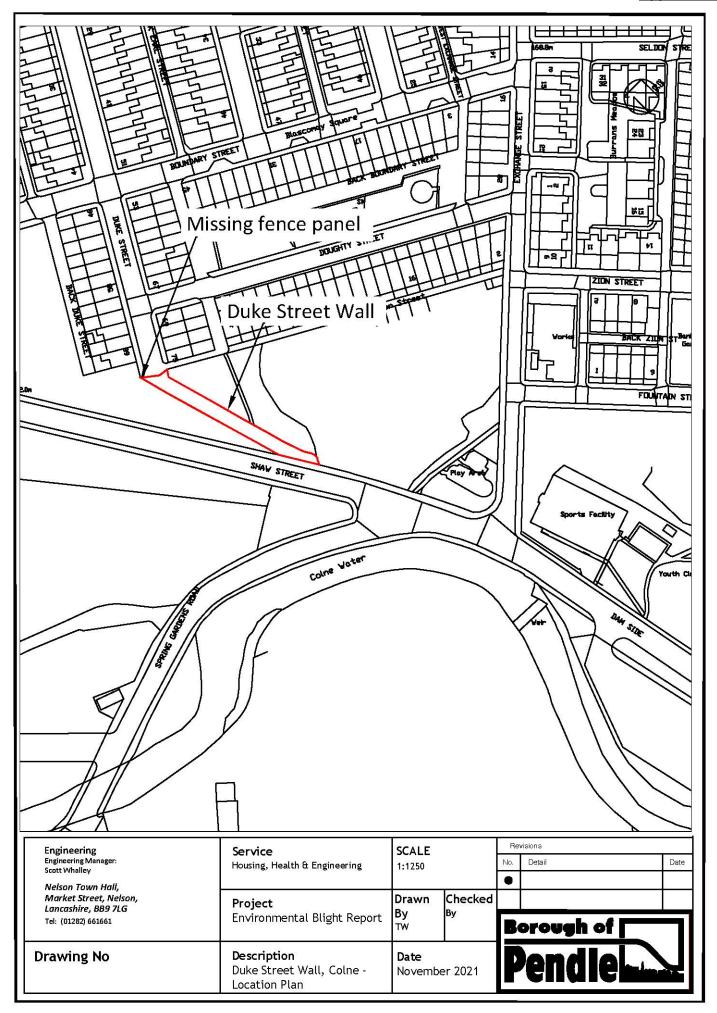
Site	Owner	Issue	Area Committee Resolution	Current Position
a) Cobbled area of Duke Street leading to Shaw Street (see attached location plan)	PBC-owned land; unadopted cobbled road	It was reported that rubbish was being dumped in an area that was being accessed due to a collapsed wall and fencing. Where the fencing was missing, people were fly-tipping	Following a site visit, it was agreed that we would price up for fixing the wall on Duke Street leading down to Shaw Street which needed repairs in a number of places to make it safe and to prevent it from further collapse. We would also get a price for repairing and refitting the missing fence panel which was found on site	The wall on Duke Street leading to Shaw Street has now been repaired/patched. We are waiting for a price to fix the fence panel

Duke Street Wall – Before and After Photographs
