REPORT FROM: PLANNING, ECONOMIC DEVELOPMENT & REGULATORY SERVICES MANAGER

DATE: 31ST MARCH, 2021

21/004/TCA – Section 211 Notice for removal of trees at Heyroyd, Skipton Road, Colne

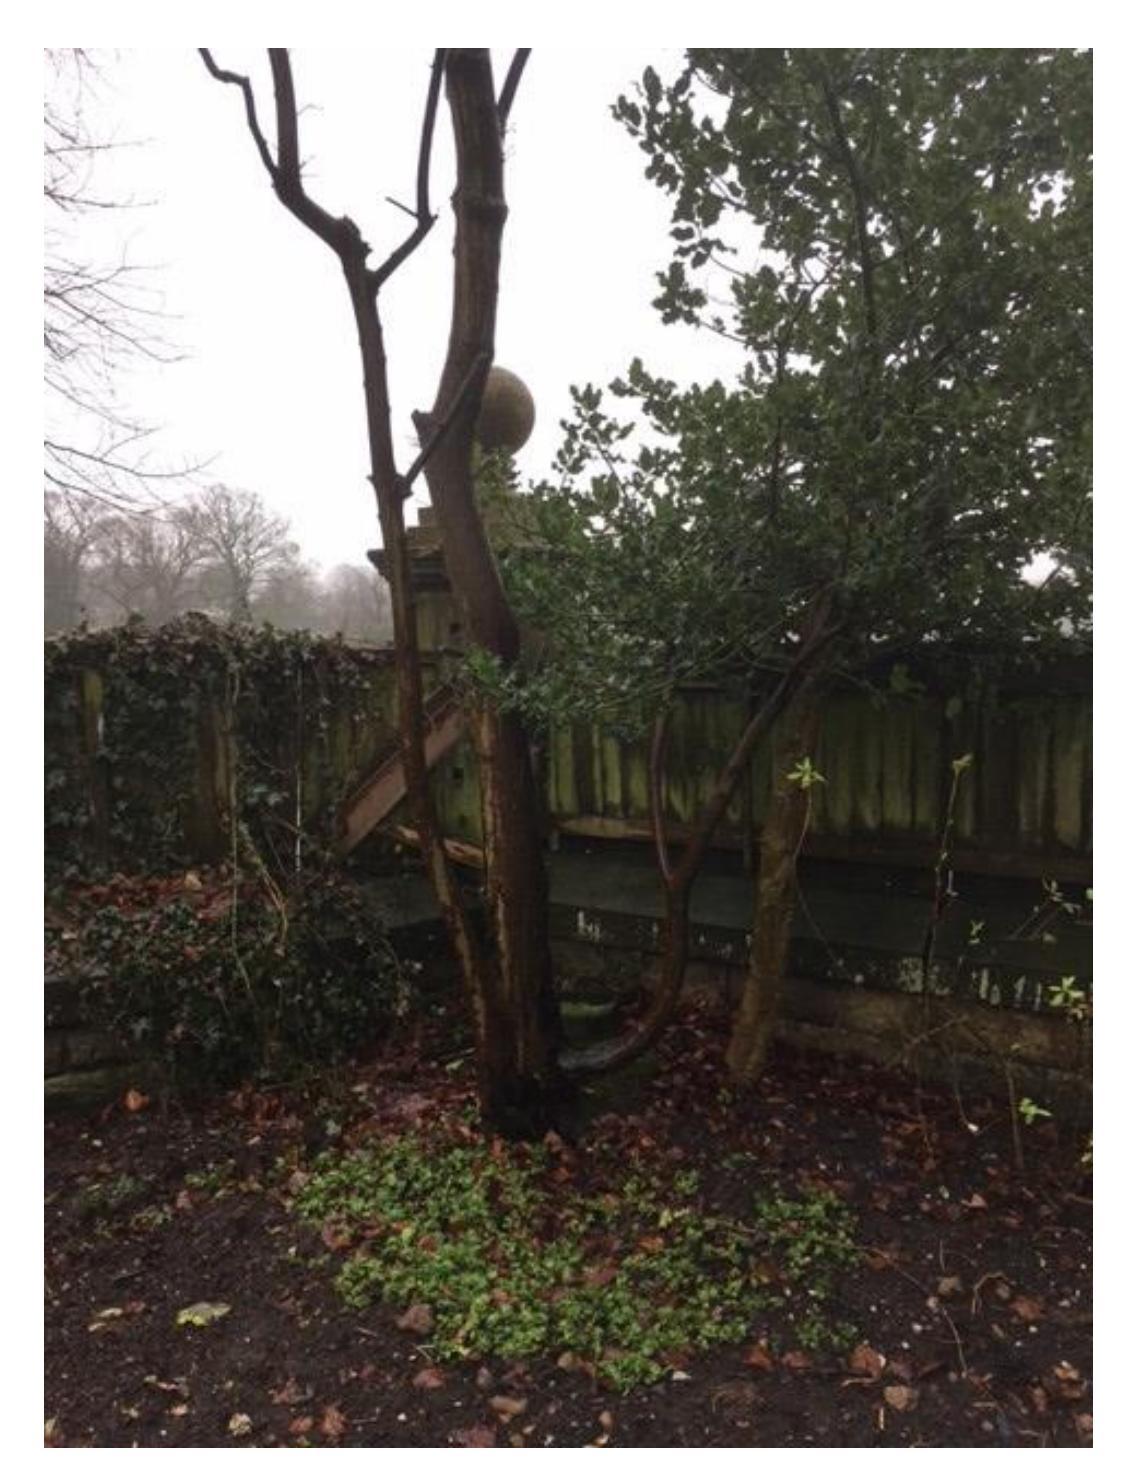
Figure 1 - T1 Elm

- 5. Both Elms are relatively young trees. T1 (see appendix 1 for map) has lost bark at the base and rot is evident. T2 has an included joint in the base which bark damage. Dutch Elm Disease is still prevalent within the Borough it is unlikely that the trees will reach maturity. While they are close to the road and clearly visible they are not specimens of any merit. As such due to their condition and relatively low amenity value they are not suitable for Preservation Order.

That the Committee raise no objection to the removal of the trees and allow the work to go ahead.
